DIAMOND PIER[®]

FROST PERFORMANCE REPORT

Zone II, Minnesota Soils

2010

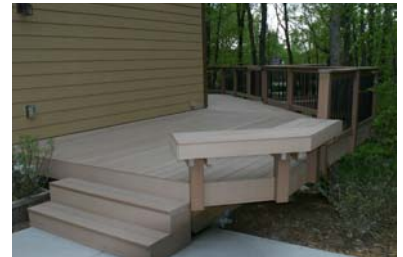
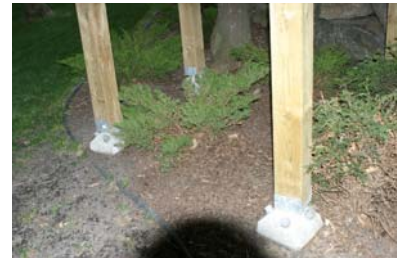
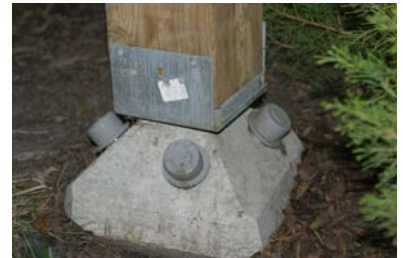
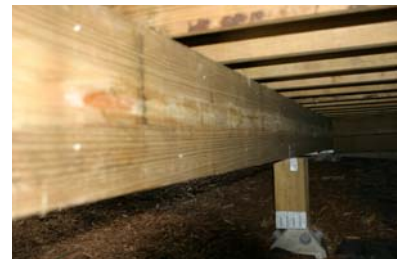
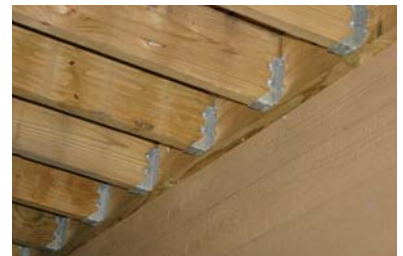
Siebrasse, Paul & Lynette

The main deck is roughly 11 feet by 33 feet and 10 feet in height. Three piers have been installed in a straight line along a common beam located approximately 11 feet from the house. Additional piers support a walkway from the structure to the driveway on the side of the house and a landing and stairway off the corner of the structure. A total of ten Diamond Piers are installed.

Observation of the soil and proximity to the Barras home described above indicates the soils are hard packed clay.

The Diamond Piers were reviewed for distress around the pin sleeves or if the pins have moved relative to the pier. No signs of distress or cracking were observed. All pins project consistently from the Diamond Piers. A sampling of the pins indicates none are loose and a measurement down the inside indicates the pins are 50 inches long. An 8-inch bullet level was used to measure the levelness of the Diamond Pier. All were level. The post connection brackets were secure and fully seated on all Diamond Piers.

A 4-foot level was used to check the levelness of the deck. All posts are plumb and the main supporting beam between the piers is level and tightly secured to the posts. There are no indications of differential movement between the piers.

The joists are level and the ledger board connecting to the house was reviewed. All of the joist brackets are secure and no sign of prying is apparent.

There are no indications of any foundation movement or degrading of the structure.

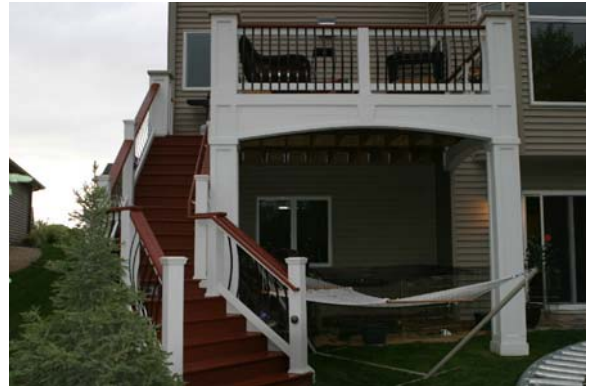
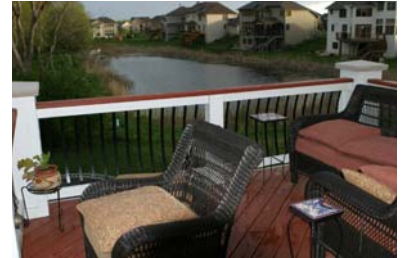
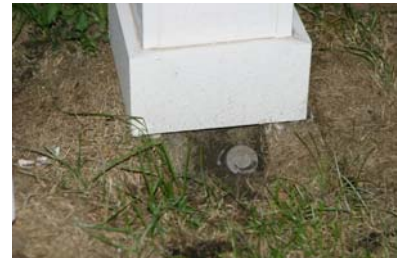
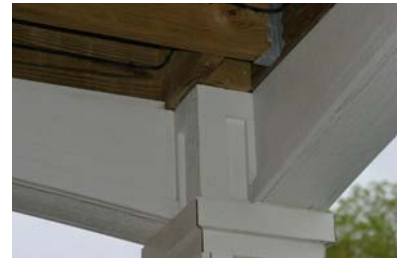
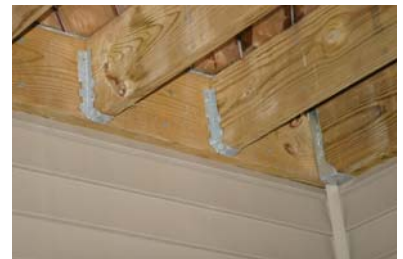
Architectural elements obscured direct observation of the Diamond Piers and the supporting structure. I was able to observe one pin and its projection is consistent with other projects. It was not loose and a measurement down the inside of the pin indicates 50 inch pins were used on the project.

A 4-foot level was used to check the levelness of the deck. The joists are level and the hangers at the ledger board attached to the home are tight. No prying was apparent.

There are no indications of any foundation movement or degrading of the structure.

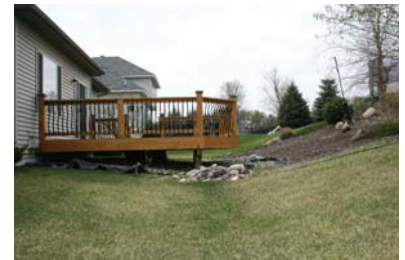
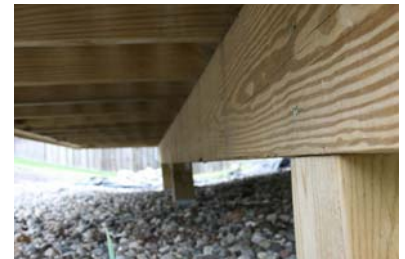
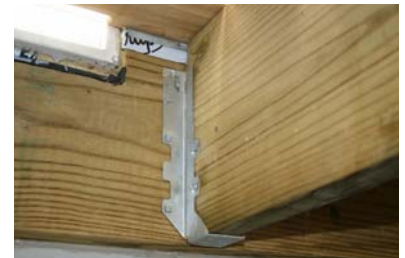
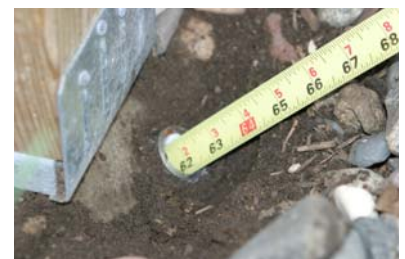
Larson, Randy

The deck in question is roughly 16 feet by 20 feet and 2 feet in height. Three piers support a common beam installed 14 feet from the house. The yard slopes towards the house and the homeowner reports that water saturates the soil around and under the deck as it drains from the hillside. The homeowner reports the site drains quickly and the soil is sandy and no water enters the basement of the house after heavy rains.

The piers were buried underground and the low deck made access difficult. I was able to observe one pier and its pins. The pier was not damaged and the pin projection is consistent with that found on other projects. None of the pins are loose and a measurement down the inside indicates 63 inch pins were used on the project.

A 4-foot level was used to check the levelness of the deck. The joists and decking are level, as is the crossbeam. The posts are tight to the pier and beam. I was able to observe the ledger beam from each end. The hangers at the ledger board attached to the home are tight. All hangers appeared to be tight to the ledger board.

There are no indications of any foundation movement or degrading of the structure.

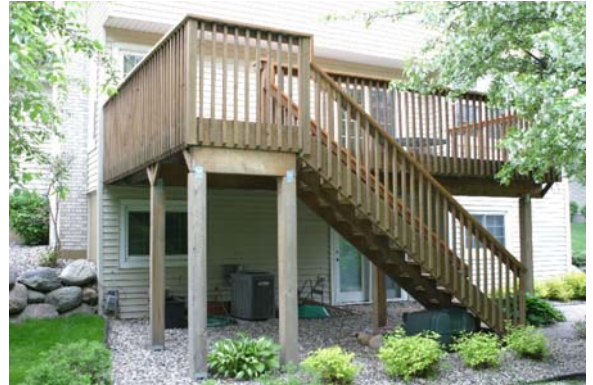
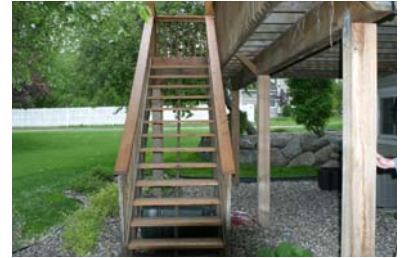
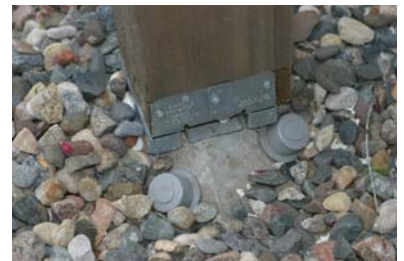
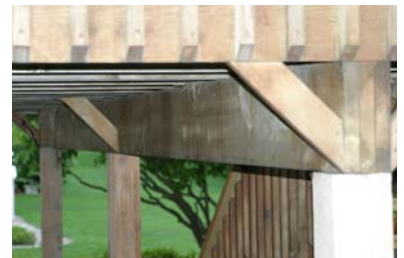
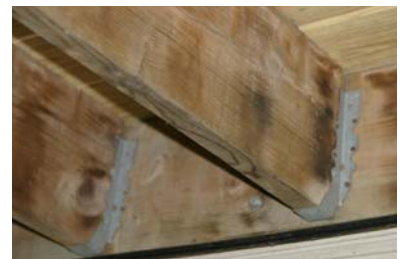
Loven, Ron

The deck in question is roughly 11 feet by 22 feet and 10 feet in height. Three piers support a common beam installed 10 feet from the house. Two additional piers are installed at a stair landing along the front of the deck. The yard slopes steeply away from the home towards a ravine approximately 35 feet from the deck.

The piers were all installed level and the pins project consistently from each pier. One pier has a slight spall around one pin. No cracking was observed. None of the pins are loose and a measurement down the inside indicates 60 inch pins were used on the project.

The post base brackets are level against the pier and the posts are tightly secured. The posts to beam connections are tight and no gaps were observed.

A 4-foot level was used to check the levelness of the deck. The joists and decking are level, as is the supporting beam. The joists are connected to the ledger board using metal joist brackets. The joist brackets are secure and no sign of prying is apparent.

There are no indications of any foundation movement or degrading of the structure.

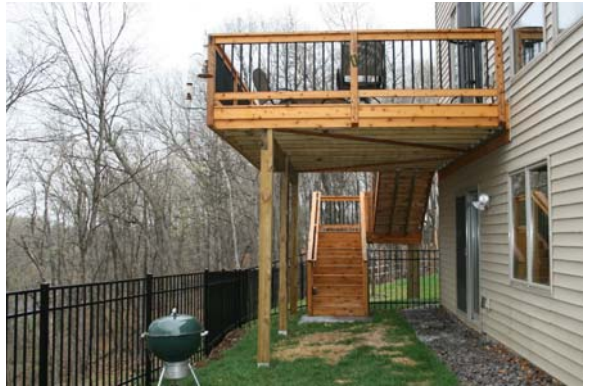
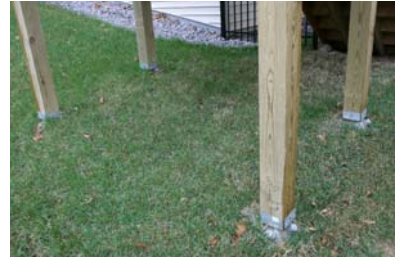
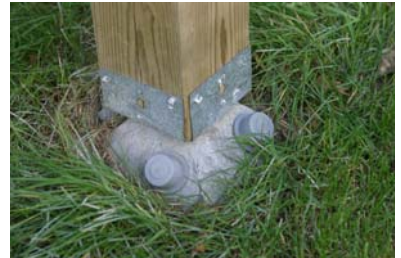
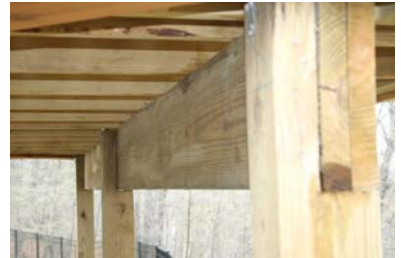
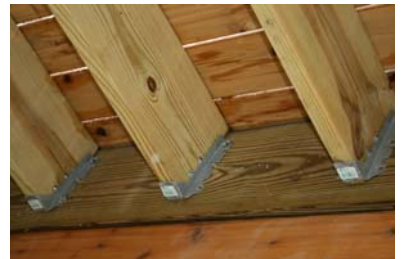
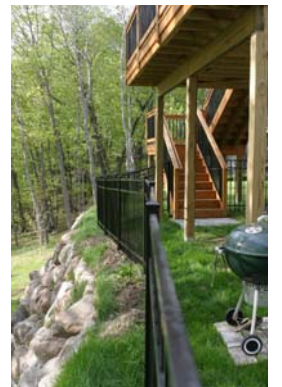
Hlushko, Dean & Alley

The deck in question is roughly 12 feet by 17 feet and 10 feet in height. Three piers have been installed in a straight line along a common beam located approximately 10 feet from the house. Four additional piers support a stairway from the structure. The site consists of a large engineered fill with a 15-foot tall rock retaining wall. No drainage issues are apparent.

The Diamond Piers were reviewed for distress around the pin sleeves or if the pins have moved relative to the pier. No signs of distress or cracking were observed and all the pins project consistently from the Diamond Pier. A sampling of the pins indicates none are loose and measurements down the inside indicate the pins are 50 inches long. An 8-inch bullet level was used to measure the levelness of the Diamond Pier. All were level. The post connection bracket was secure and fully seated on the Diamond Pier.

A 4-foot level was used to check the levelness of the deck. All posts are plumb and the supporting beam between the piers is level and tightly secured to the posts. There are no indications of differential movement between the piers.

The joists are level sloped slightly away from the house and the ledger board connecting to the house was reviewed. All of the joist brackets are secure and no sign of prying is apparent.

There are no indications of any foundation movement or degrading of the structure.

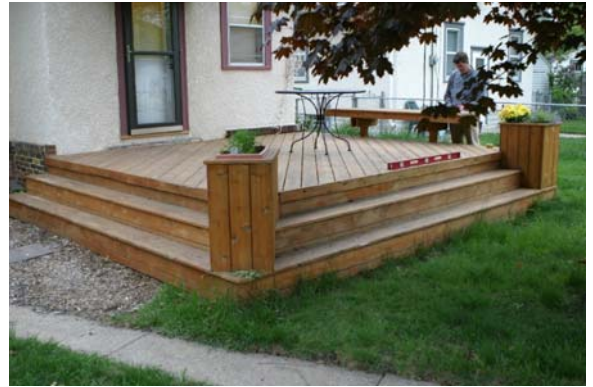
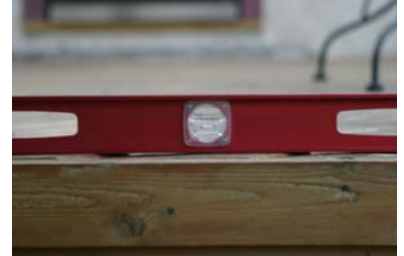
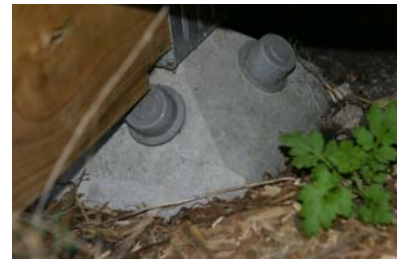
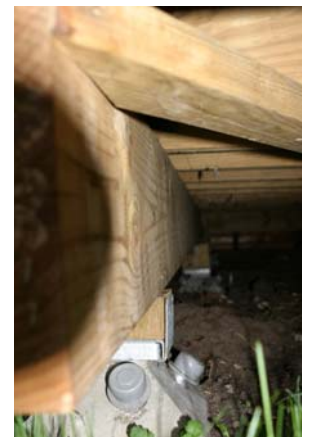
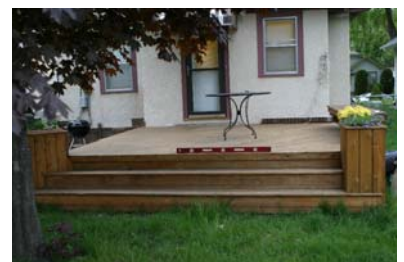
Hanson, Laura

The deck in question is 12 feet by 14 feet and 2 feet in height. The deck is freestanding and is not attached to the house. By code, footings extending to frost depth are not required for freestanding decks. The deck is supported by two beams with three Diamond Piers per beam. The first beam is located 2 feet from the house running parallel to the house. The second beam was located ten feet from and running parallel to the first beam.

All six piers observed, but access was restricted due to the height and finished sides of the deck. Two piers were reviewed: The first pier closest the house was level and two pin length measurements were taken: one pin length is 17 inches and the other is 29 inches. It appears a short pin was used in order to install the pier close to the house. The second pier was found to be approximately 1/2" out of level and the wood post does not bear fully on its connection bracket. But the post to beam connection was tight indicating that the pier was installed out of level and adjustments were made in the framing. One pin measurement was taken at this pier and the length is 33 inches.

A 4-foot level was used to check the levelness of the deck. The joists and decking are level, as are the supporting beams. No distress was observed in the framing joints, which would indicate that the second pier was installed out of level originally, and the framing compensated for the tilt of the pier.

There are no indications of any foundation movement or degrading of the structure.

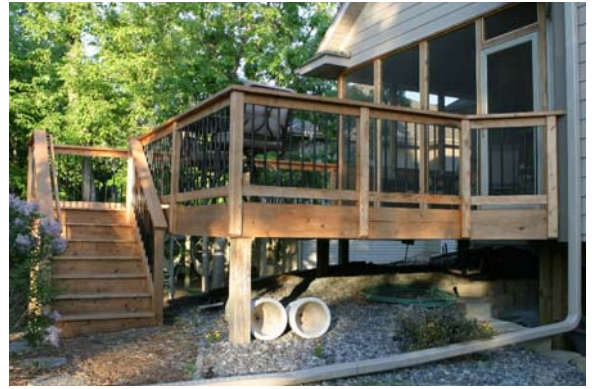
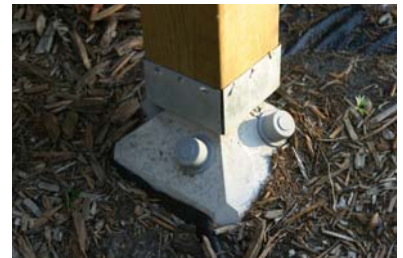
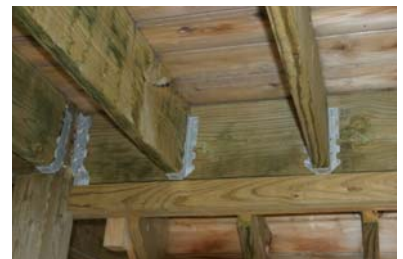
Remme, Mark

The structure supported by Diamond Piers is roughly 4 feet by 12 feet and 5 feet in height and is an addition to a deck set on conventional concrete piers. One diamond pier supports a beam which is framed into the existing structure. The two remaining piers support the landing of a stairway. The yard slopes steeply away from the home towards a ravine approximately 10 feet from the deck.

The piers were all installed level and the pins project consistently from each pier. None of the pins are loose and a measurement down the inside indicates 63 inch pins were used on the project. The post base brackets are level against the pier and the posts are tightly secured. The posts to beam connections are tight and no gaps were observed.

A 4-foot level was used to check the levelness of the deck. The joists and decking are level, as is the beam supported at one end by a diamond pier.

In the portion of the structure supported on Diamond Piers, there are no indications of any foundation movement or degrading of the structure.
